The Search for 'Defects' by Non-invasive Techniques: Development and Application of Pulsed-Transmissive and Reflective Thermography in Fiberglass Material

Gastón Sanglier Contreras*, Eduardo J. López Fernández
Sonia Cesteros García and Roberto A. González Lezcano

Departamento de Arquitectura y Diseño
Escuela Politécnica Superior
Universidad CEU San Pablo, Spain

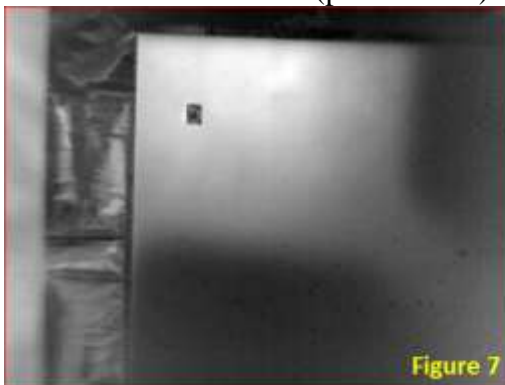
Figure 7 shows the defect, in this case a lift-off, with very little contrast, as it is located on the other side of the test tube, i.e. closer to the side where the area is

heated and not to the side where the surface is observed with the camera. A dark square appears corresponding to the aluminium tape which, due to its difference in emissivity with the paint on the surface to be inspected, helped to focus the camera and to serve as a scale (size H x W = 11mm x 8.5 mm) in the possible indications on the specimen.

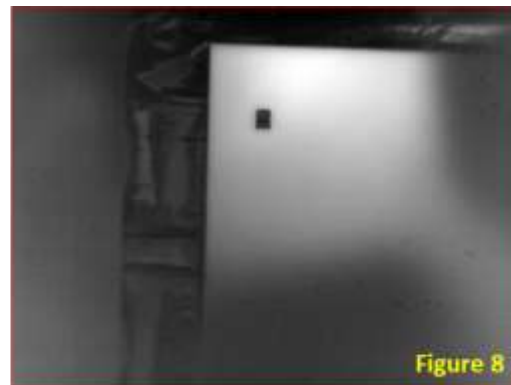
Figure 8 shows the same area A, but with the difference that it has now been heated and viewed from the same side, i.e. front face or painted side. No indication (possible defects) has been observed there.

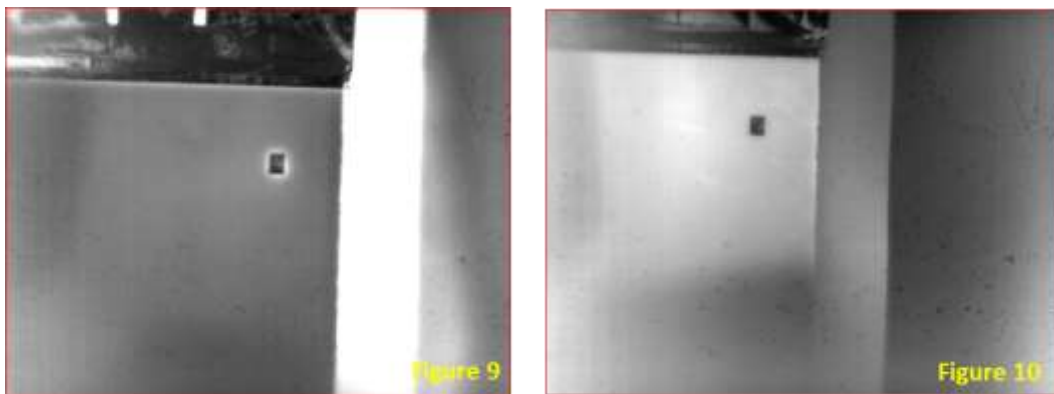
Figures 9 and 10: Image of the A-zone of the specimen taken by internal transmission (figure 9) and the image of the A-zone of the test piece taken by internal reflection (figure 10).

Figure 9 shows a defect in the upper central part, but it is shown with very little contrast to that observed in figure 7. Subsequently, the test tube was turned over, heating the painted side and looking at the unpainted side. Figure 10 shows a higher contrast image of the defect, because it is closer to the face on the side facing the camera.

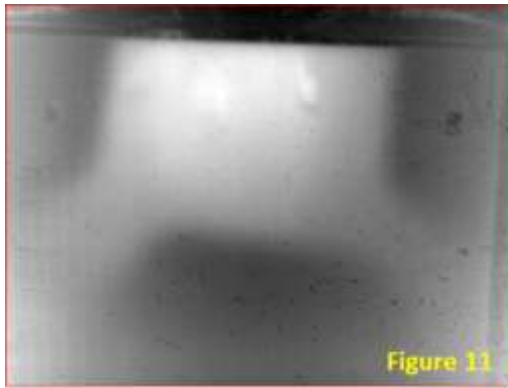
In figure 11, if the upper part is seen to be lighter (heated), the take-off appears on the right of the image, while the holes are on the left. In this thermography it is verified that the takeoff is better detected, since a dark zone is observed, due to the accumulation of the material that has concentrated there after having made this defect of somewhat artisan form. In the defective part due to the holes, a marked zone is observed, but each hole cannot be distinguished individually (three holes were made at different depths). In the thermography of figure 12 no indication has been observed.

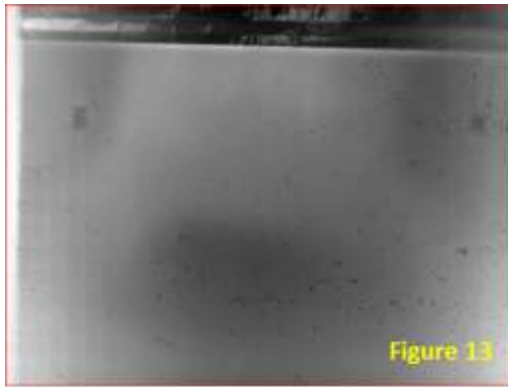
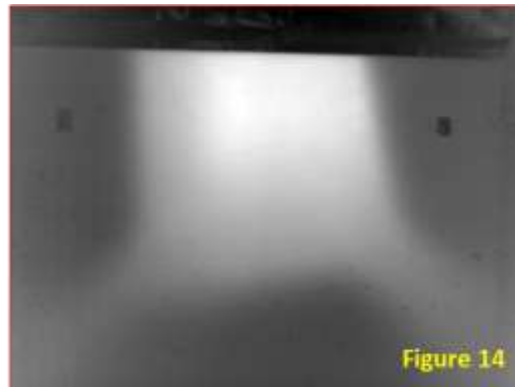
Figures 13 and 14: Image of the Zone-B of the test tube taken by internal transmission (figure 13) and the image of the B-zone of the specimen taken by internal reflection (figure 14).

In the thermography of figure 13 the take-offs are observed, in addition to the zone of holes, but with less contrast than in figure 11. In the thermography of figure 14 there are no indications of possible defects, or defective areas.

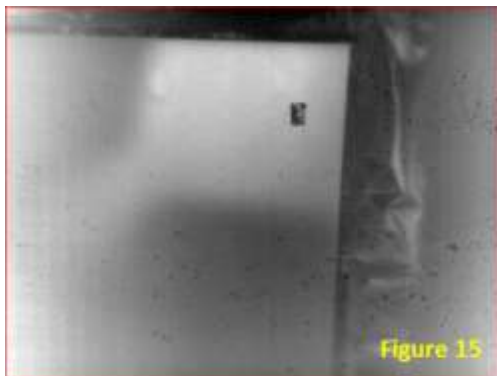
In zone C, a core rupture of the material has been created as a defect. It can be seen, in figure 15, that the defect in the central part corresponding to the take-off is better seen than the defect in this zone, because it is closer to the surface observed by the camera.

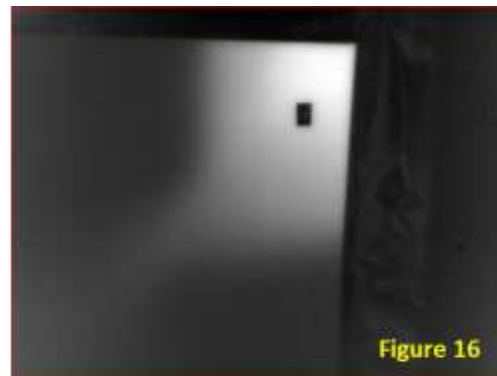
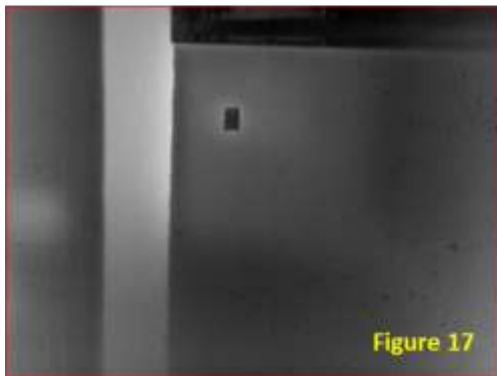
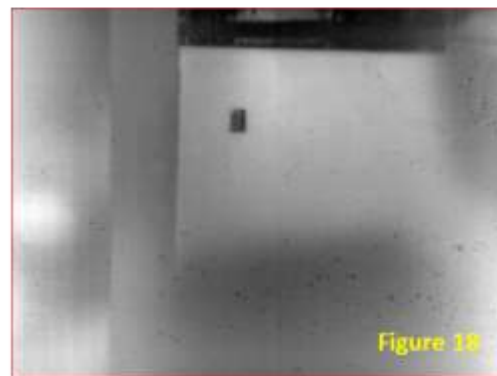
In the two subsequent thermographies, which correspond to figures 16 and 17, there are no indications. However, in figure 18, next to the right of the black square of reference, a white rectangular zone can be seen (warmer due to the accumulation of heat in this zone) which corresponds to the defect generated there of core breakage of the material.

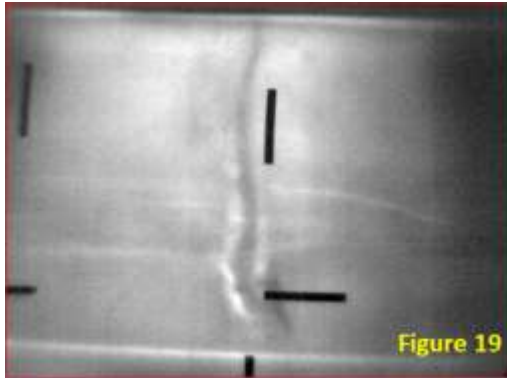
Figure 19 corresponds to a thermography obtained by external transmission, now the painted part of the radome is seen by the camera, and the unpainted part is heated. In this figure a longitudinal indication of dark colour can be seen that goes from the upper part of the image to the lower part. This indication probably corresponds to a crack repaired by accumulation of resin on it. Transversally to it, and as very fine white lines, other cracks in the piece are identified, probably not identified in a first visual inspection and not repaired. In the lower part of the image, a white line appears with a higher contrast than the previous indications, but in this case, it corresponds to the separation joint between the different panels of Rohacell material (not a defect). Dark spots also appear, but with lower contrast than the longitudinal mark, corresponding to dry areas of the piece, i.e. areas with less resin.

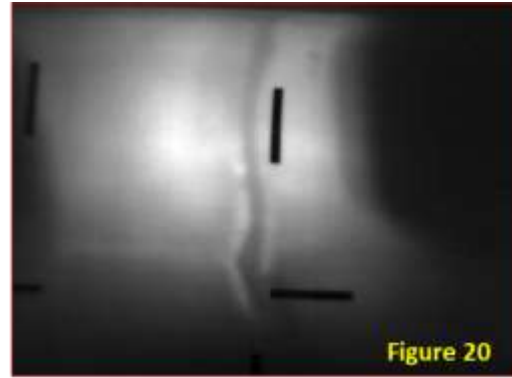
In figure 20, you can also see the dark longitudinal stain, but with less contrast than in figure 19. In this case, the cracks are not so clearly observed, and in some cases, they are not visible. The separation joint is also not visible. The heating and observation on this side seems to be at a disadvantage compared to the process used in thermography in figure 19.

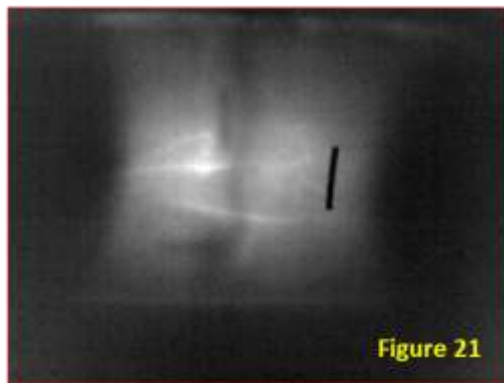
In figure 21, it has been heated on the paint side and observed on the unpainted side. It can be commented that the references (dark rectangular stains) can be seen, even though they are placed on the other side of the piece. The longitudinal indication appears with less contrast to figure 19, but the indications of the cracks (fine white lines) are well defined.

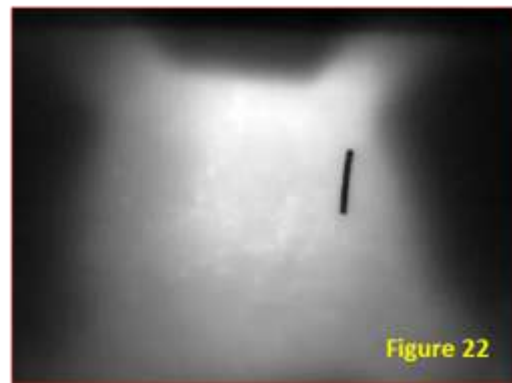
The thermography in figure 22 shows the internal structure of the camera (radome), and the above indications are not visible, since they are on the other side of the inspected part, that is, the opposite side of the one observed by the infrared sensor.

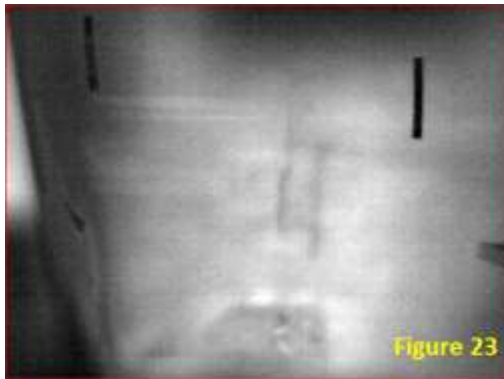
In figure 23, there are two vertical indications in dark colour, and another dark area in the lower part of the analysed area. With regard to the vertical indications, it can be noted that the repaired crack on the part can be seen with the naked eye, which is the crack on the right, but the other vertical indication next to it cannot be seen. By means of this technique, it does become evident. The dark spot at the bottom corresponds to an area of the part where little resin has been applied (dry area). There you can see folds in the fabric.

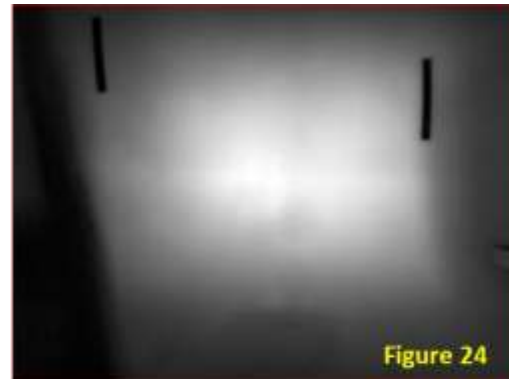
In the thermography of figure 24 only the lower indication appears and with less contrast, which may indicate that the indication, or zone of little resin, may be more towards the outside than the vertical indications.

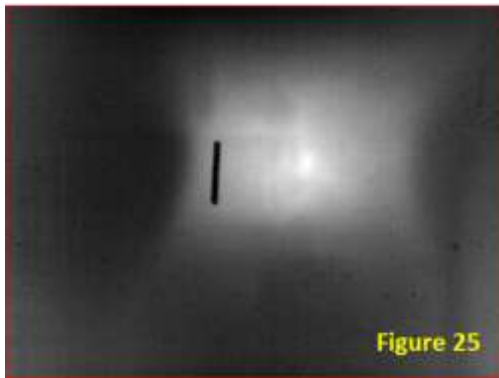
In figure 25 the vertical indications are not clearly visible, so it can be concluded that they are closer to the painted surface.

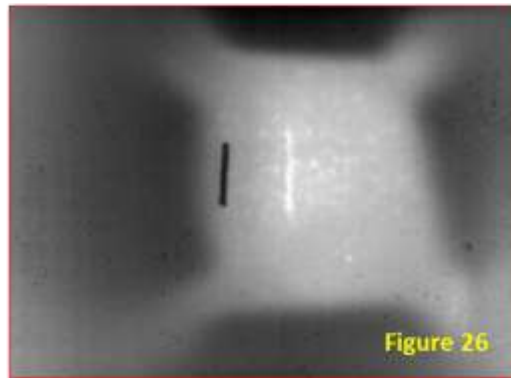
In figure 26, the crack located more to the right appears and it does it in white color. Now it is observed by the most favorable side to be seen, since at simple sight it is observed by this side. There are also some white lumps belonging to the internal structure of the piece.

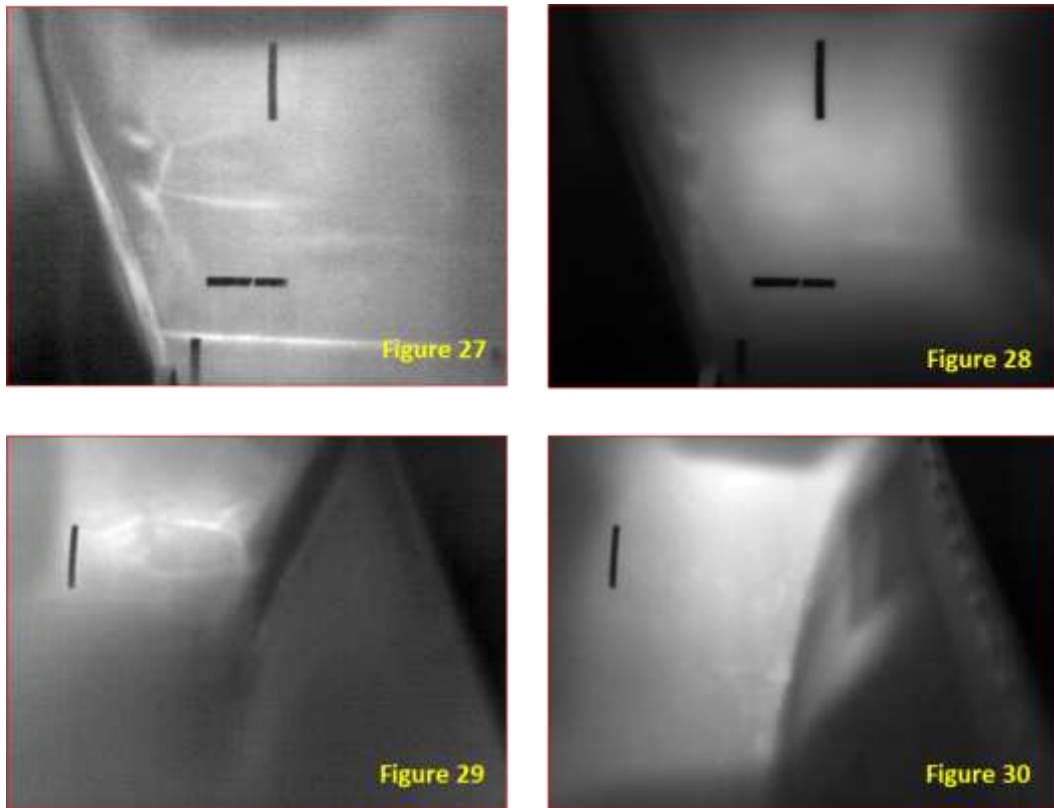
Figure 27 shows, in the upper left part, a series of white lines with different inclinations, corresponding to the crack itself and its branches. Below, as a longitudinal line of greater contrast in white, the joint of the piece appears. In figure 28, the crack is shown in a very diffuse way and with little contrast as it is a core break. Figure 29 shows the crack in a very detailed way with all the branches. In figure 30, there are no indications, except for an area of lumps which give more indication, greater contrast, than the crack itself.

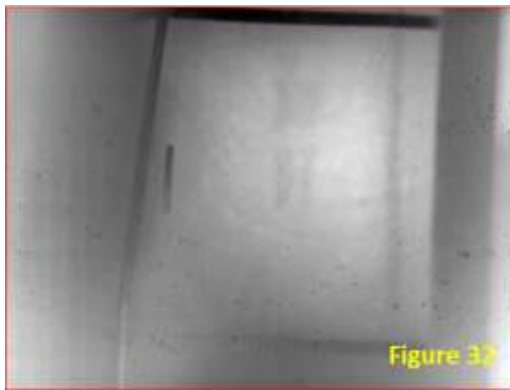
Figure 32 shows the monolithic part of the piece where two rectangular zones appear in a slightly darker colour than the background. The lower rectangular area is slightly more diffused than the upper one, although it is the area that is being seen directly with the camera. This may be due to the fact that this area of delamination created has more air pockets than the one at the back.

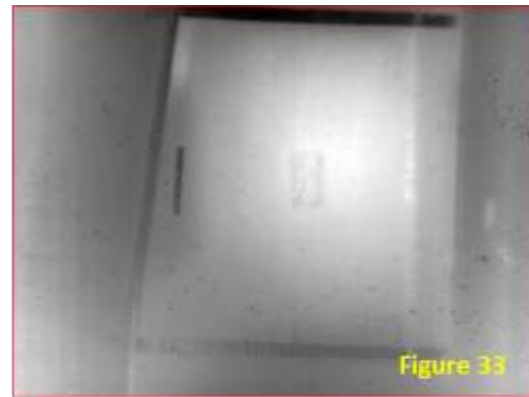
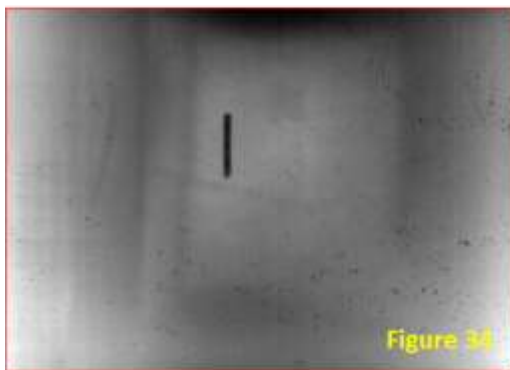
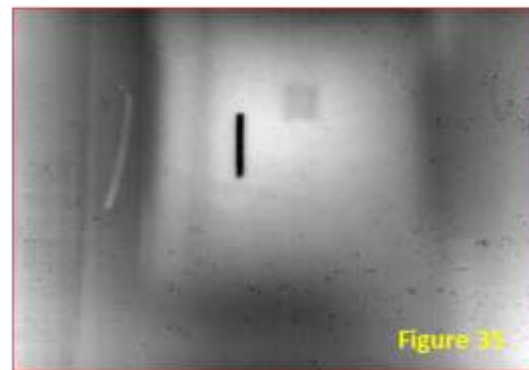
Figure 33 shows the lower delaminated area. From the upper zone (delaminations on the back) there are no indications. Figure 34 shows nothing. Neither of the two delaminated areas can be seen. Figure 35 shows the upper delaminated area. In this case, it is now the most favorable area to be seen.

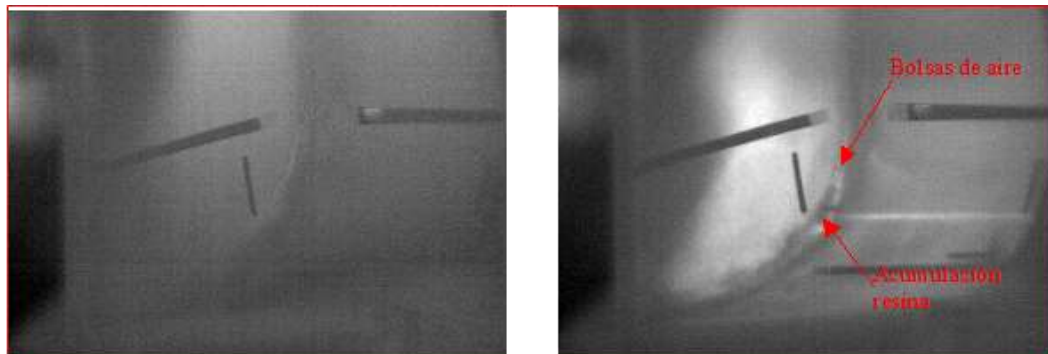
The thermography on the left, in figure 36, corresponds to the moment before the piece is heated. The study zone, in this case the edge of the piece is at room temperature. The thermography on the right corresponds to the heated edge after the heat pulses. It shows irregular spots corresponding to the air and resin pockets.

Figure 36: Air and resin pockets on the edge of the part (right-hand thermograph).

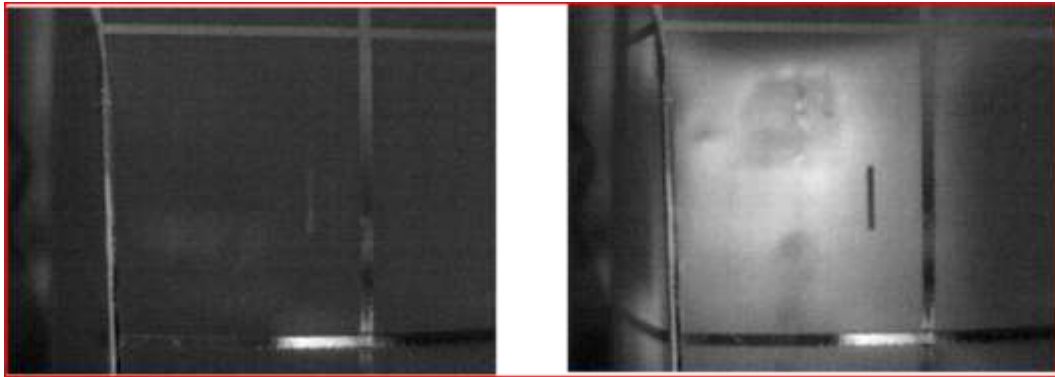
The thermography on the right, in figure 37, shows two dark spots in the central zone due to 'dry zones' with very little resin application, it is another type of detected irregularities in the surface of the part.

Figure 37: Material accumulation stains and folds in the part.
