The Search for 'Defects' by Non-invasive Techniques: Development and Application of Pulsed-Transmissive and Reflective Thermography in Fiberglass Material

Gastón Sanglier Contreras*, Eduardo J. López Fernández
Sonia Cesteros García and Roberto A. González Lezcano

Departamento de Arquitectura y Diseño
Escuela Politécnica Superior
Universidad CEU San Pablo, Spain

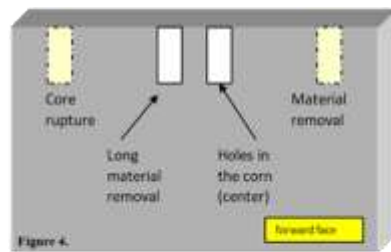
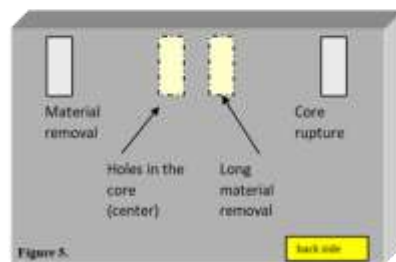
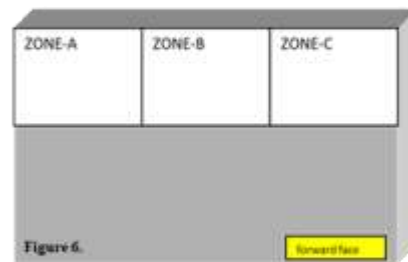
For the development of the test methodology, a specimen was manufactured from the same material as the part to be inspected, and with the same thicknesses for the development of the inspection method. Different defects were made in it: core breakage, detachments and holes at different depths. For the inspection of the specimen, it was divided into three zones, looking at the specimen from the front side, the upper left side was called A-zone, the central part B-zone, and finally the right side was called C-zone, as shown in the following figure 6.

Figures 4, 5 and 6: Test tubes with different defects on the front side (figure 4) and on the back side (figure 5). Distribution of different zones with defects in the test piece (figure 6).

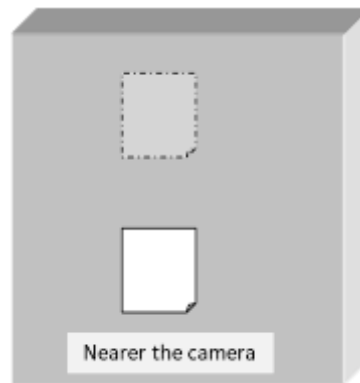
Figure 31: Diagram of delaminations in the piece.

The manufacture of this type of defect has been carried out by hand. For this purpose, air pockets have been created by means of a release agent, surrounded by tape all around, in such a way that no air enters the delaminated area. Two 'delaminated zones' have been placed, one in the part of the piece to be inspected closer to the chamber, and the other, above it, in the part furthest away, that is, closer to the focus. The arrangement of both delaminated zones is shown in Figure 31.
